A Case Study

In-Situ Tailshaft Machining

Background To The Tailshaft Repair

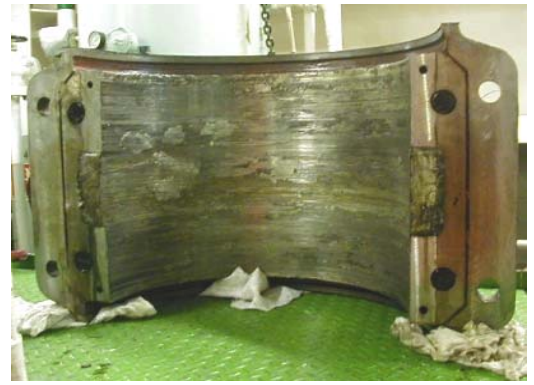
The white metal bearing had failed leading to pickup and areas of deep scoring. Micrometer readings showed an undamaged area at each end of the journal. These proved suitable for use as datums for the orbital machining and polishing operation.

Damaged White Metal Bearing

Use in-situ machining and polishing to remove all signs of damage, whilst maintaining concentricity and roundness within OEM tolerances. Obtain undersize bearings to suit the repaired journal.

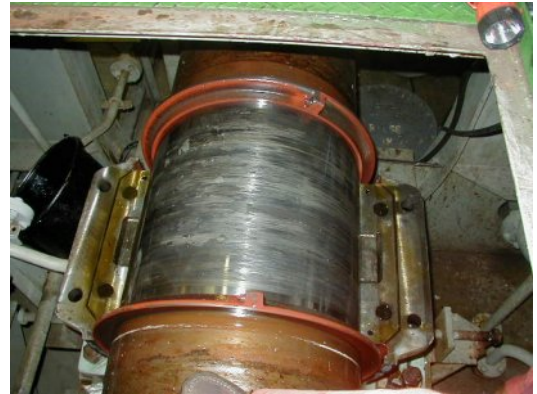
The Moscow had a failure on its 505mm diameter (400mm long) tailshaft pedestal journal. Nicol & Andrew were called in to re-machine the damaged journal in-situ, using specialised orbital equipment.

Damaged 505mm Ø Tailshaft Journal

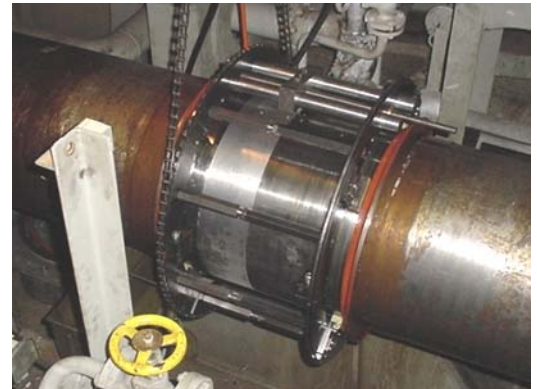
Orbital Machining Of The Journal

We used our orbital machining head to remove the damage, referencing the undamaged concentric areas at each end of the journal. Frequent checks using clock gauges ensured that the re-machining was maintained in perfect alignment with the original. We then polished the tailshaft to the size and surface finish required for the undersize bearings.

Due to the significant depth of damage, the in-Situ machining process took 4 days. We provided 24-hour cover to reduce the amount of time the vessel spent out of service. After fitting the new undersize bearing the shaft was run-up to full operating speed. It has suffered no further problems in service.
